**BROWARD SHERIFF'S OFFICE
DEPARTMENT OF FIRE RESCUE
AND EMERGENCY SERVICES**

LP 12 Urgent Medical Device Correction

SW 08-03

URGENT MEDICAL DEVICE CORRECTION
LIFEPAK[®] 12 and LIFEPAK 20 Defibrillator/Monitor

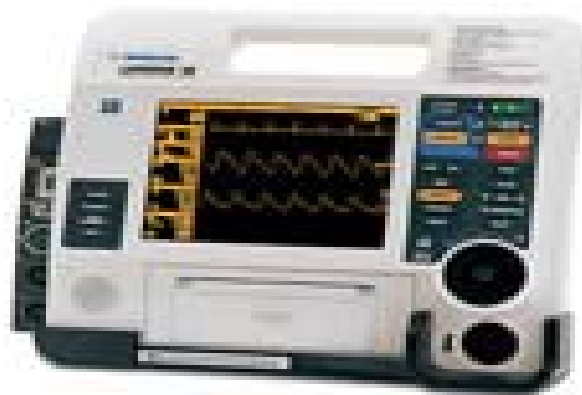
Physio-Control is notifying customers that some LIFEPAK defibrillator/monitors have a potential to incorrectly render a shock or no shock decision during **AED analysis ONLY**.

All LP 12 units owned and operated by the BSO Fire Rescue Bureau will be updated with the appropriate software by Physio-Control as they are rotated through Logistics.
